# ODI RESUME

Investigation: PE 03-039  
Prompted By: OWNER COMPLAINTS  
Date Opened: 08/11/2003  
Principal Investigator: ROBERT YOUNG  
Subject: MOTORCYCLE REAR SUSPENSION COLLAPSE

Manufacturer: AMERICAN HONDA MOTOR CO.  
Products: 2001-2003 HONDA GL1800 GOLD WING  
Population: 10000

**Subject:** Myr 2001-2003 Honda GL1800 "Gold Wing" Suspension Collapse  
due to cross-member separation.

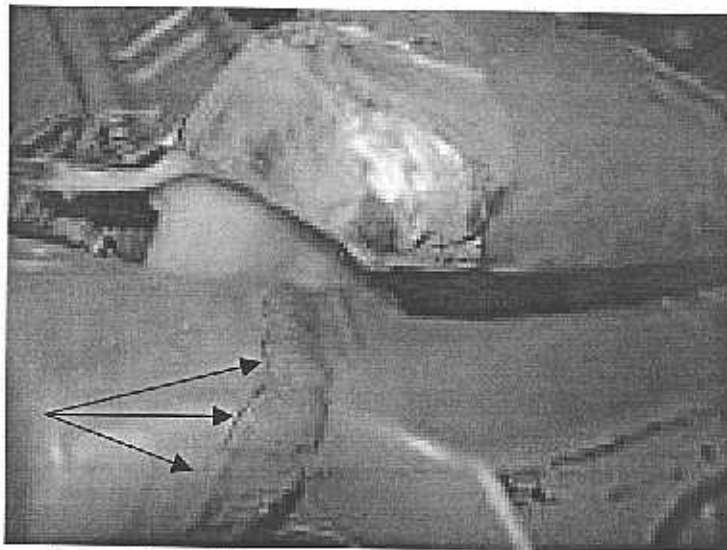
Cracked cross-member weld on VIN: 1HFSC47493A200573, Honda repurchased this motorcycle.

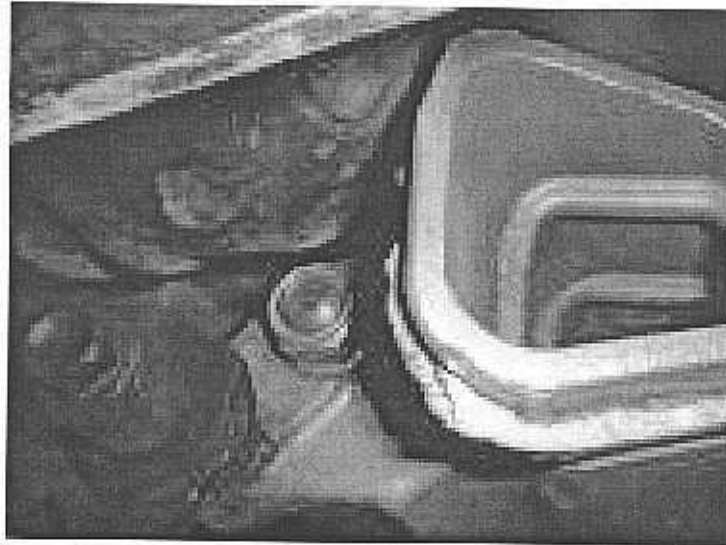
Cross-member separated while riding. VIN: 1HFSC47023A202940. Honda repurchased this motorcycle.

Same, close-up

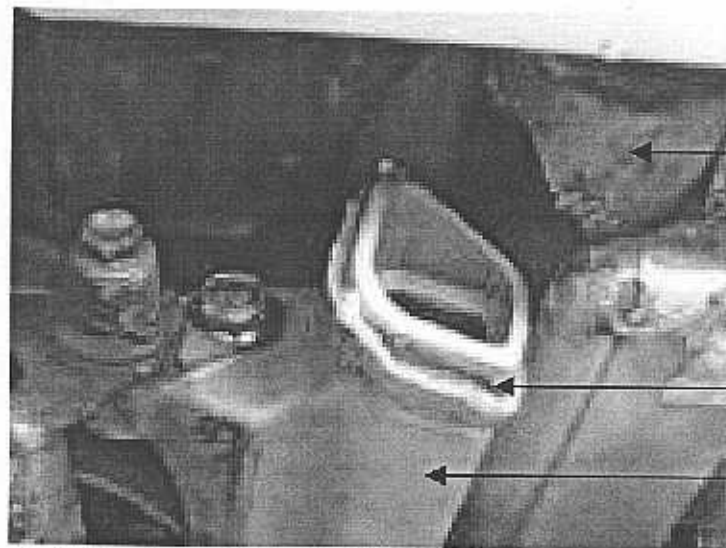
Cross-member separated while riding. VIN: 1HFSC47063A201208. Honda repurchased this motorcycle.
